# **VETIVER SYSTEM FOR DAM, POND AND LAKE BANK STABILISATION**

THE VETIVER NETWORK INTERNATIONAL

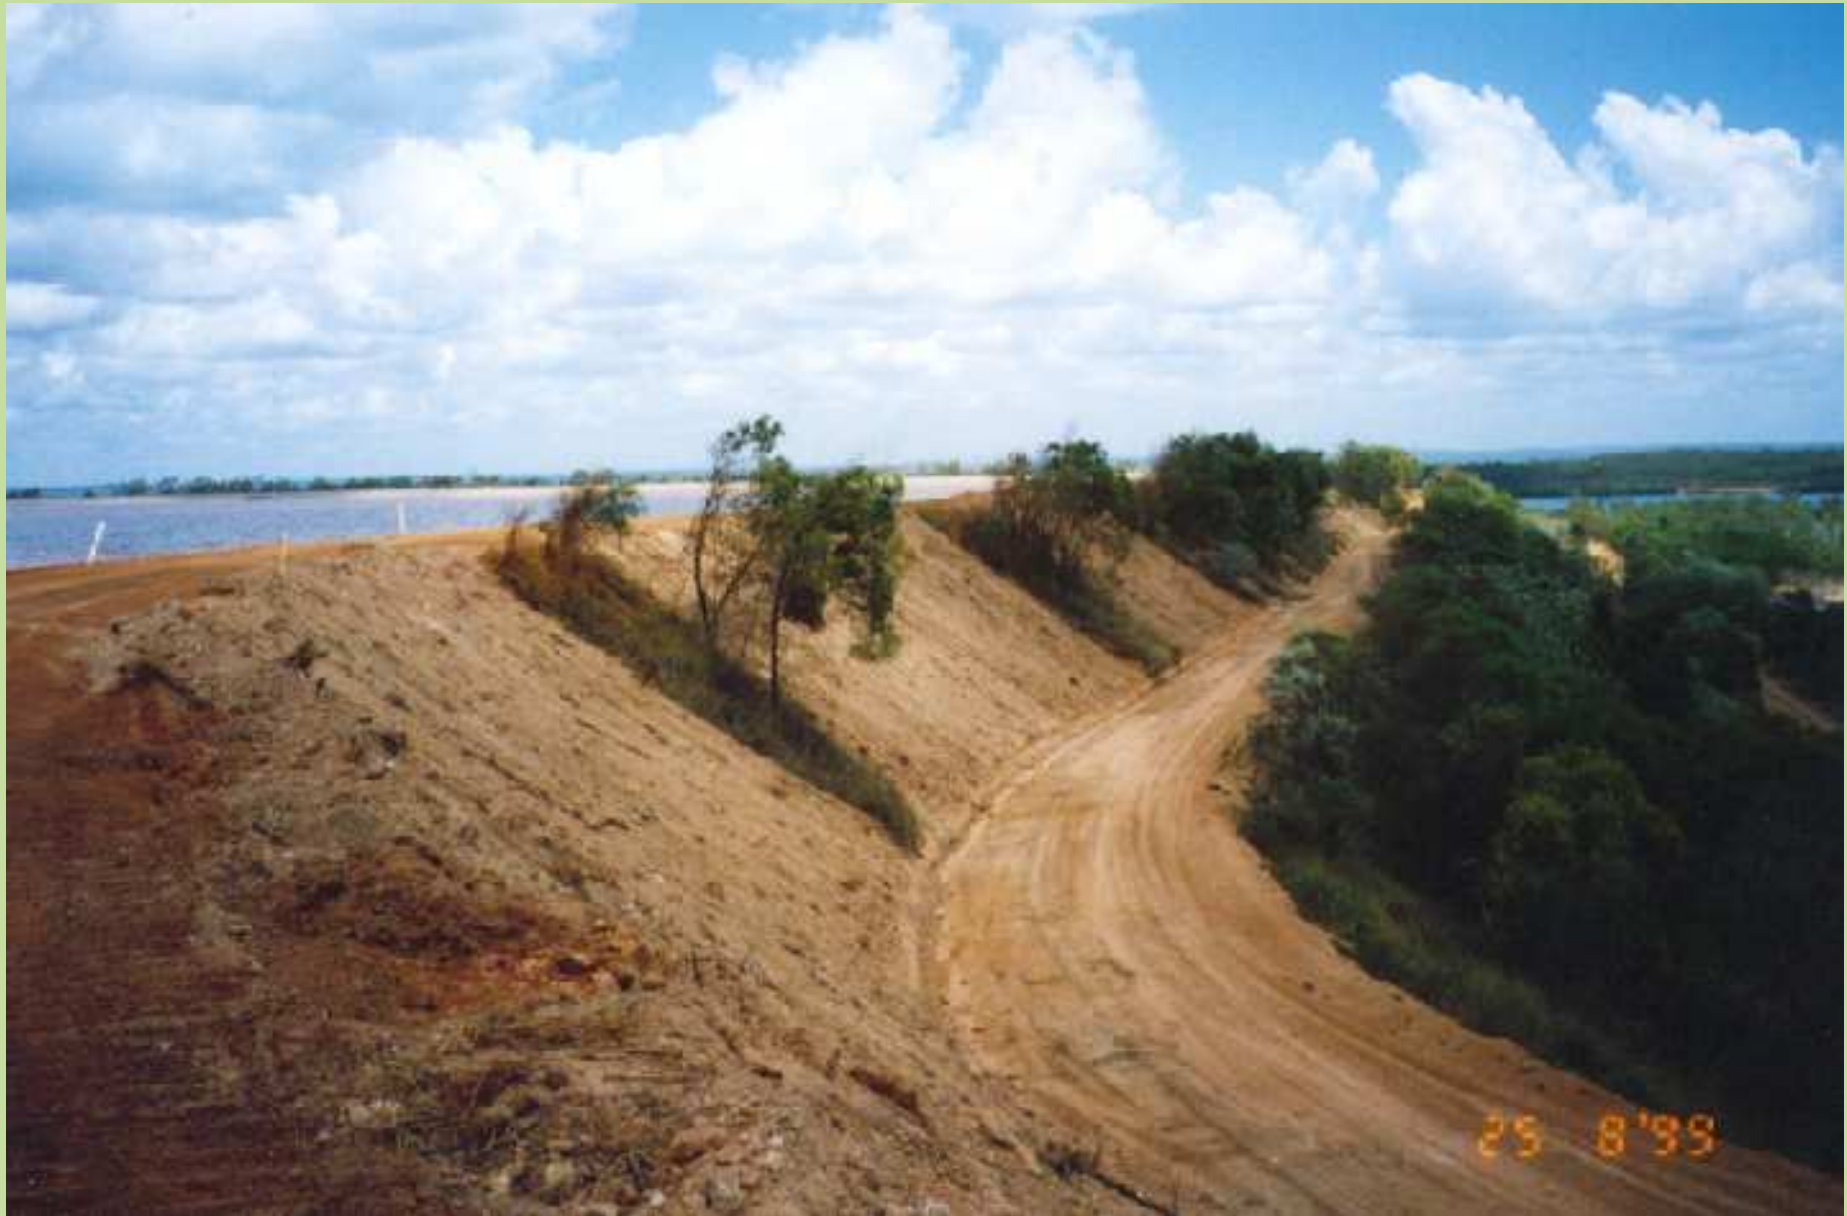
# Australia - Dam wall repaired after cyclone damage

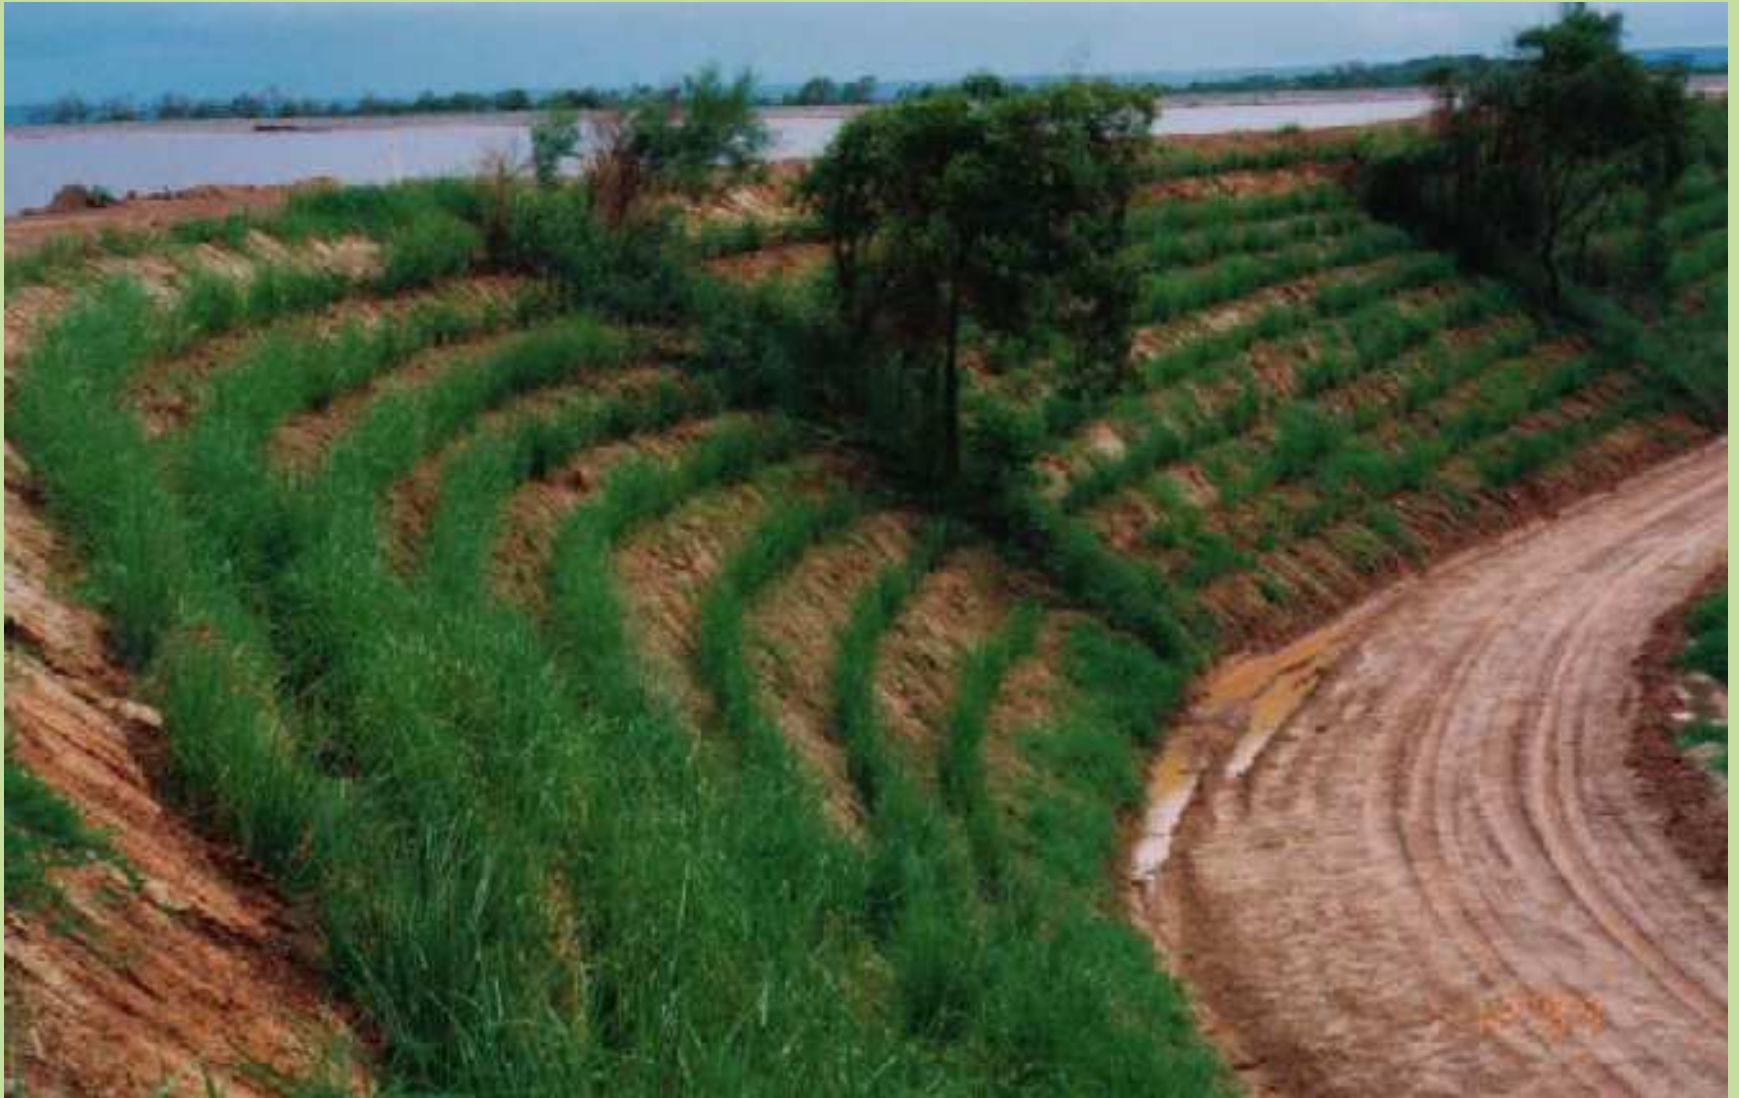
## Six weeks after planting

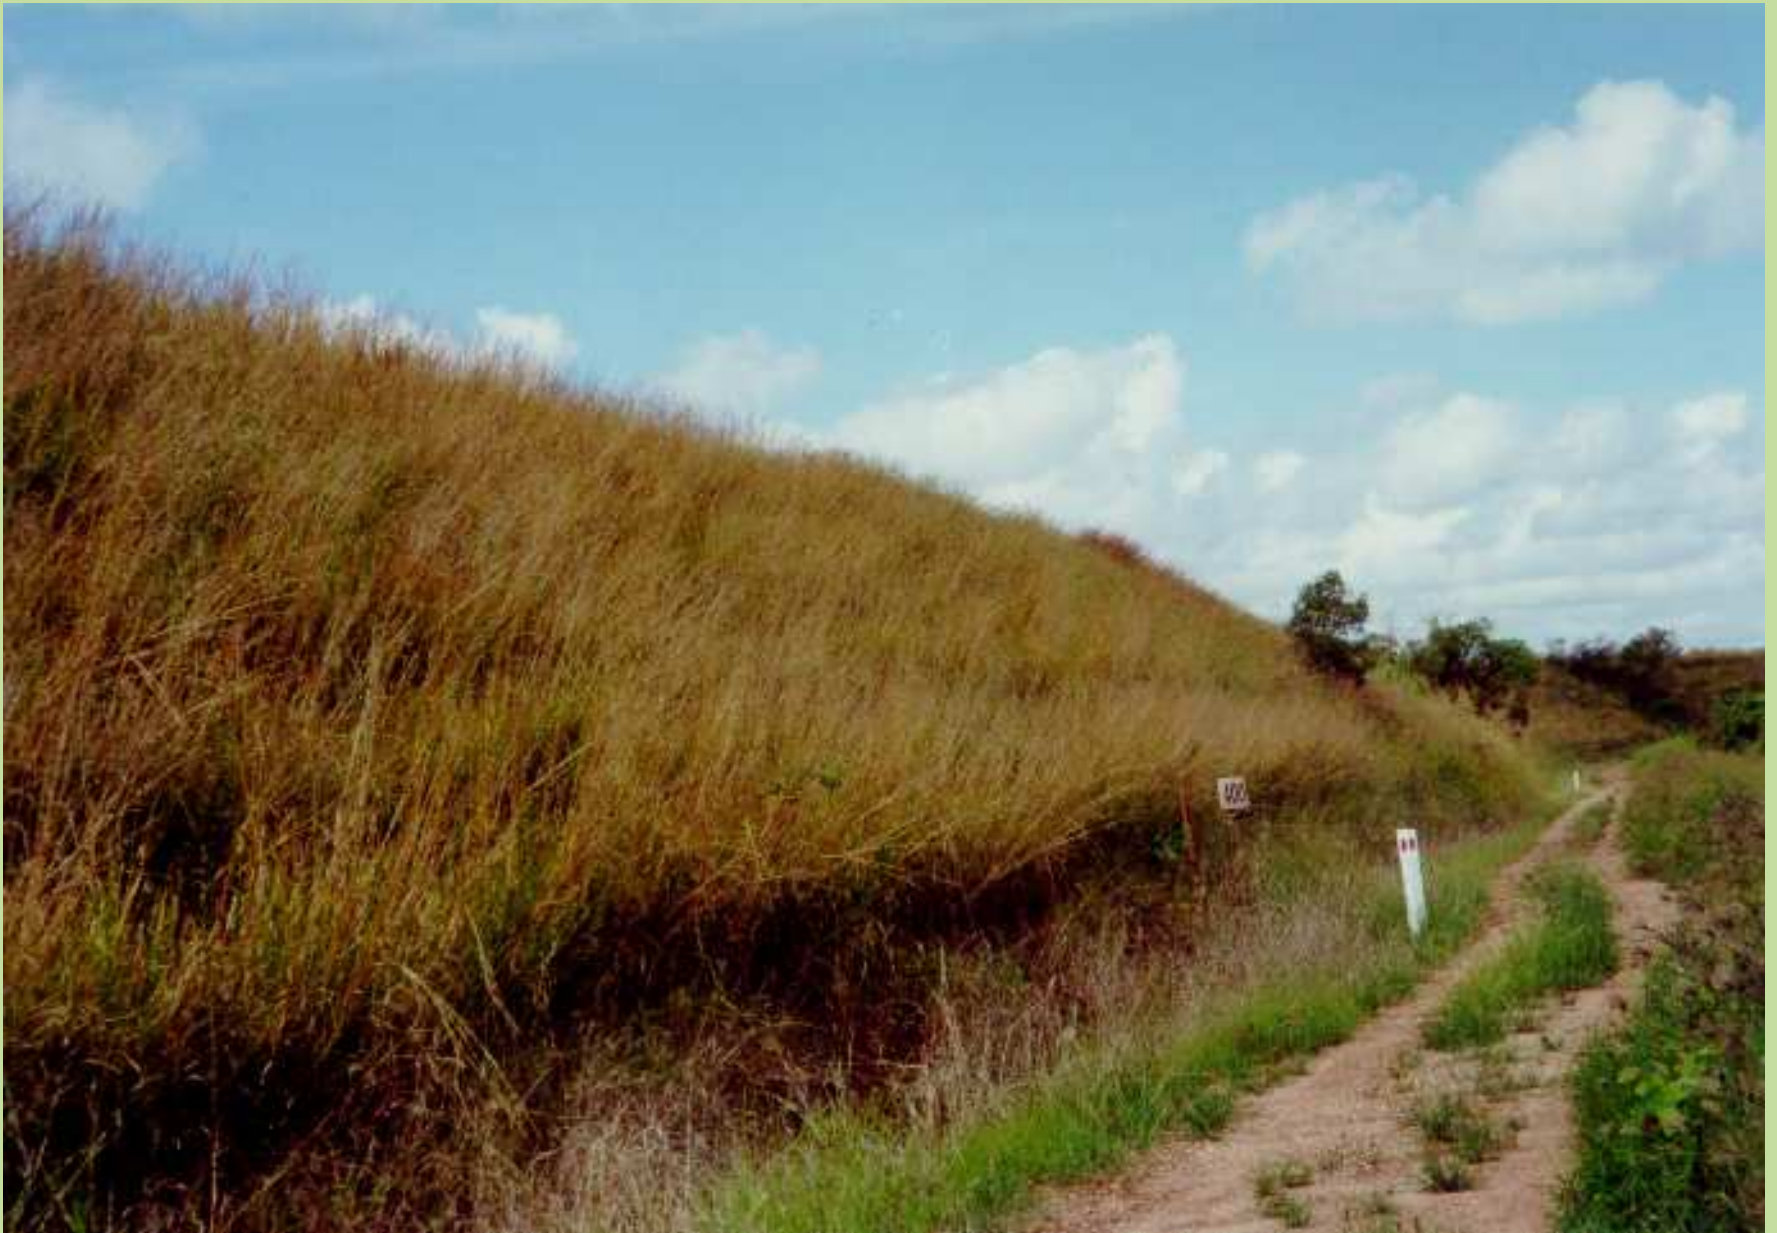
# One year after planting

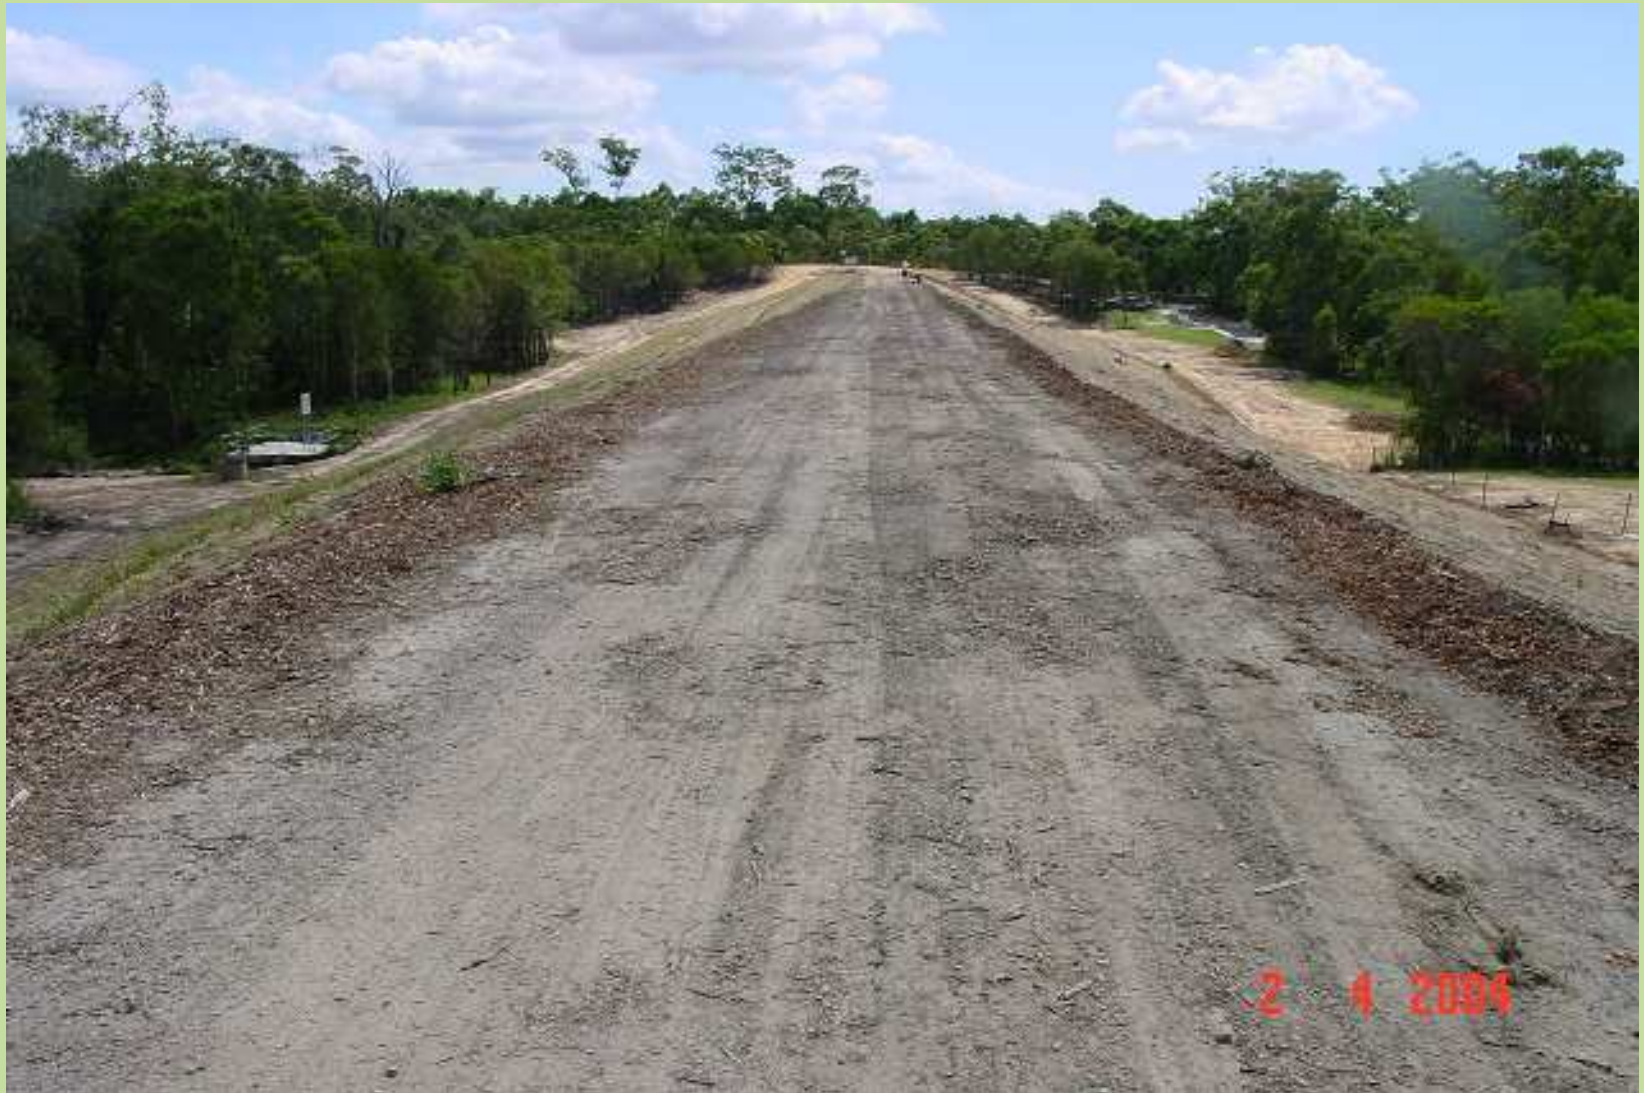
# Australia A flood control dam ready for stabilisation

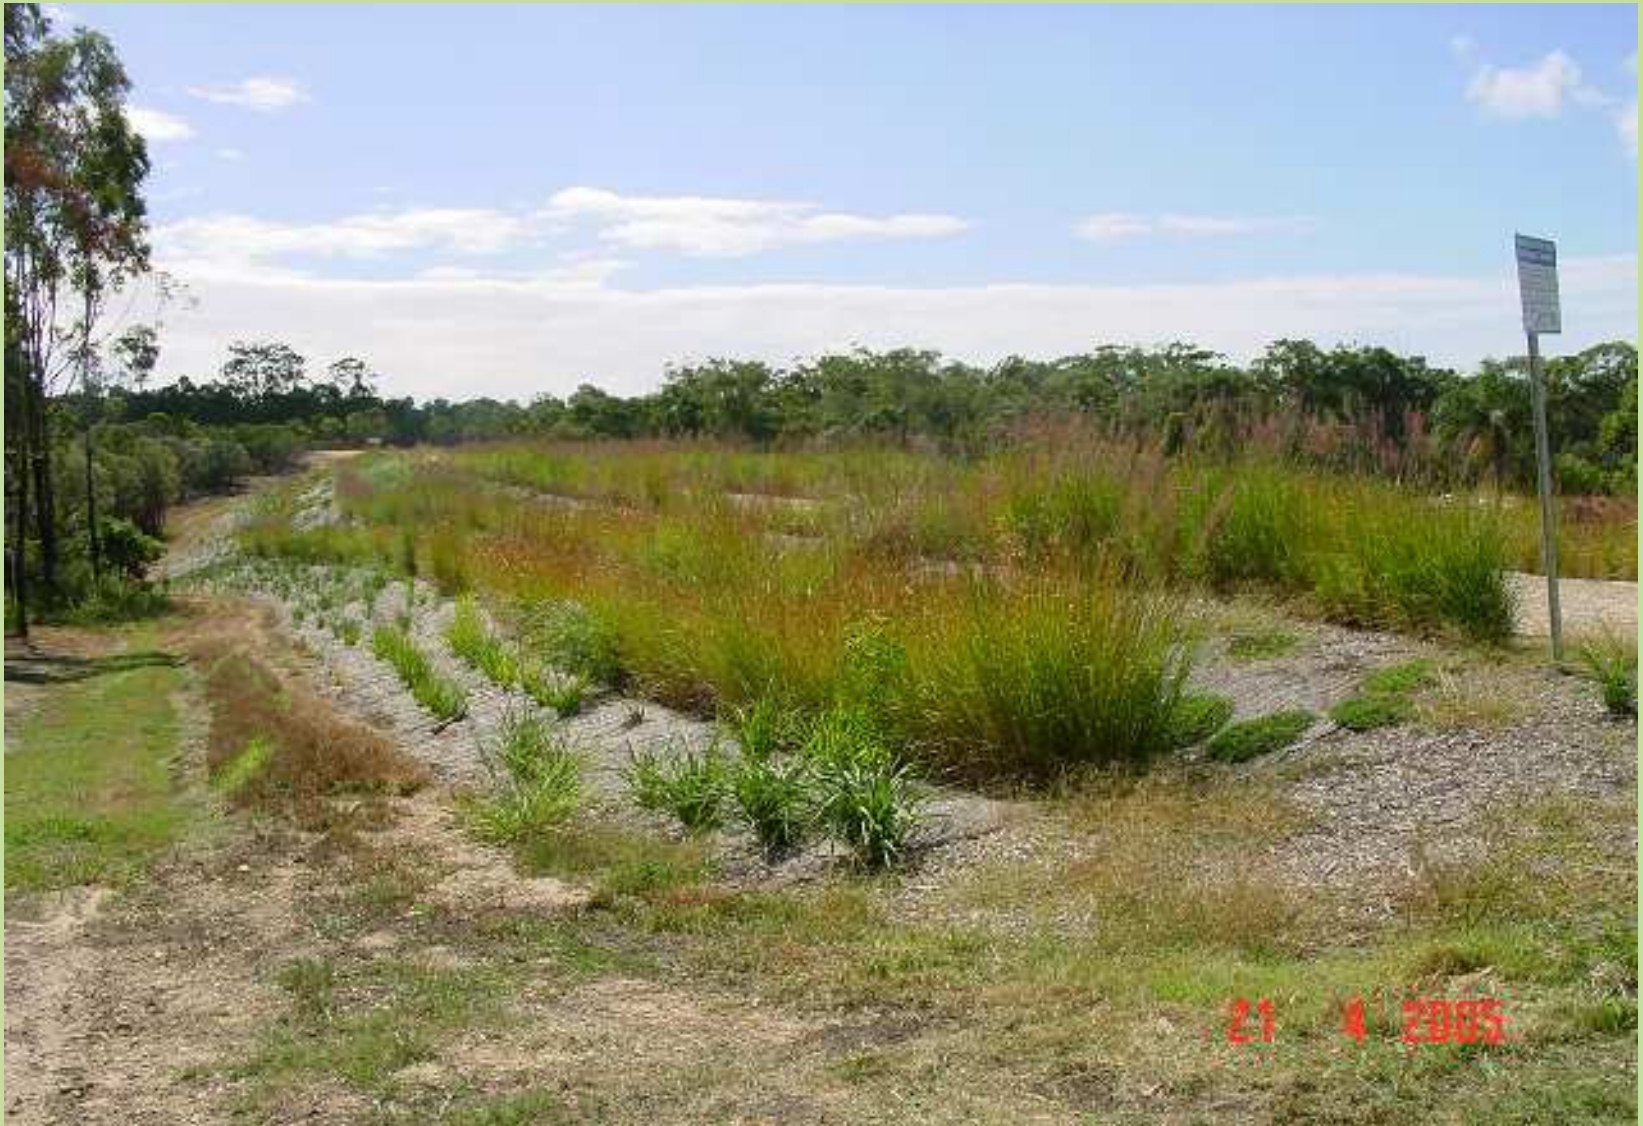
## Same dam wall one year after planting

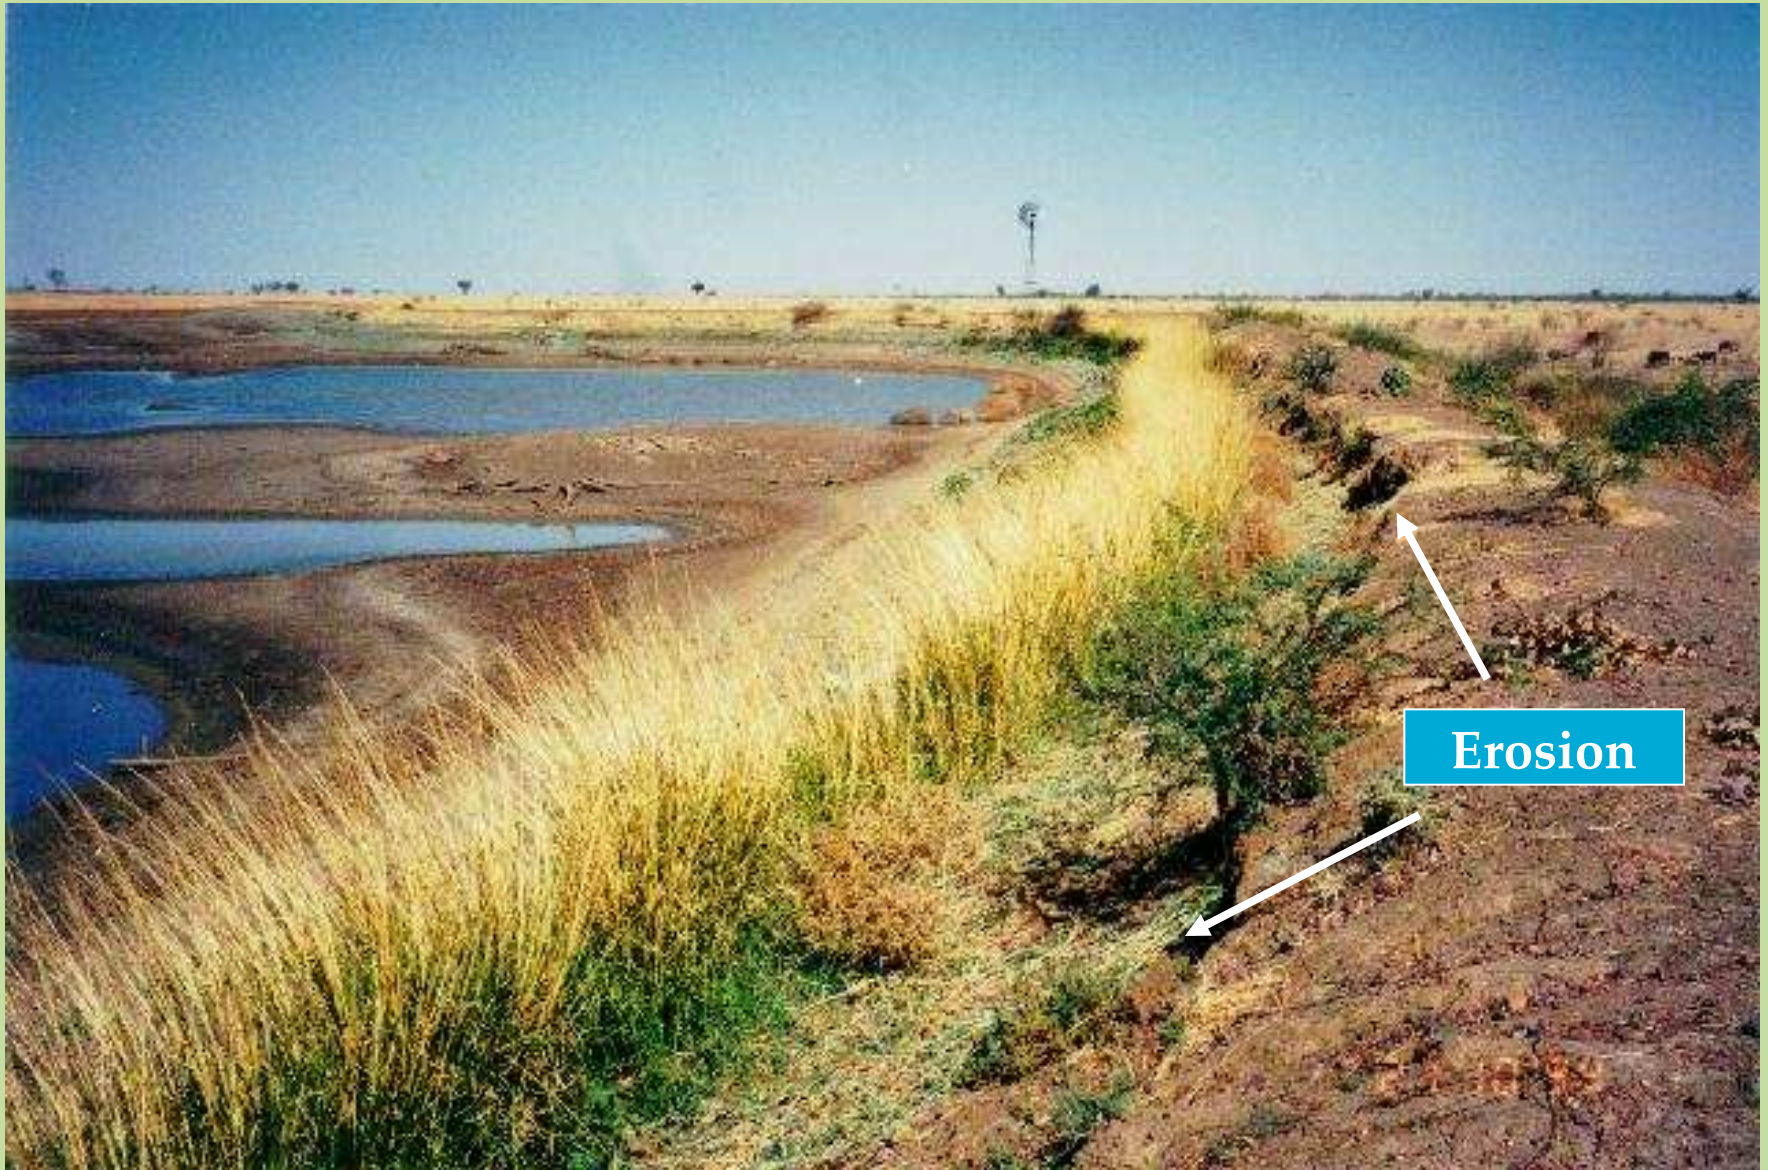
# Australia Vetiver planting on the inside wall of a large farm dam to control wave erosion during the monsoon season

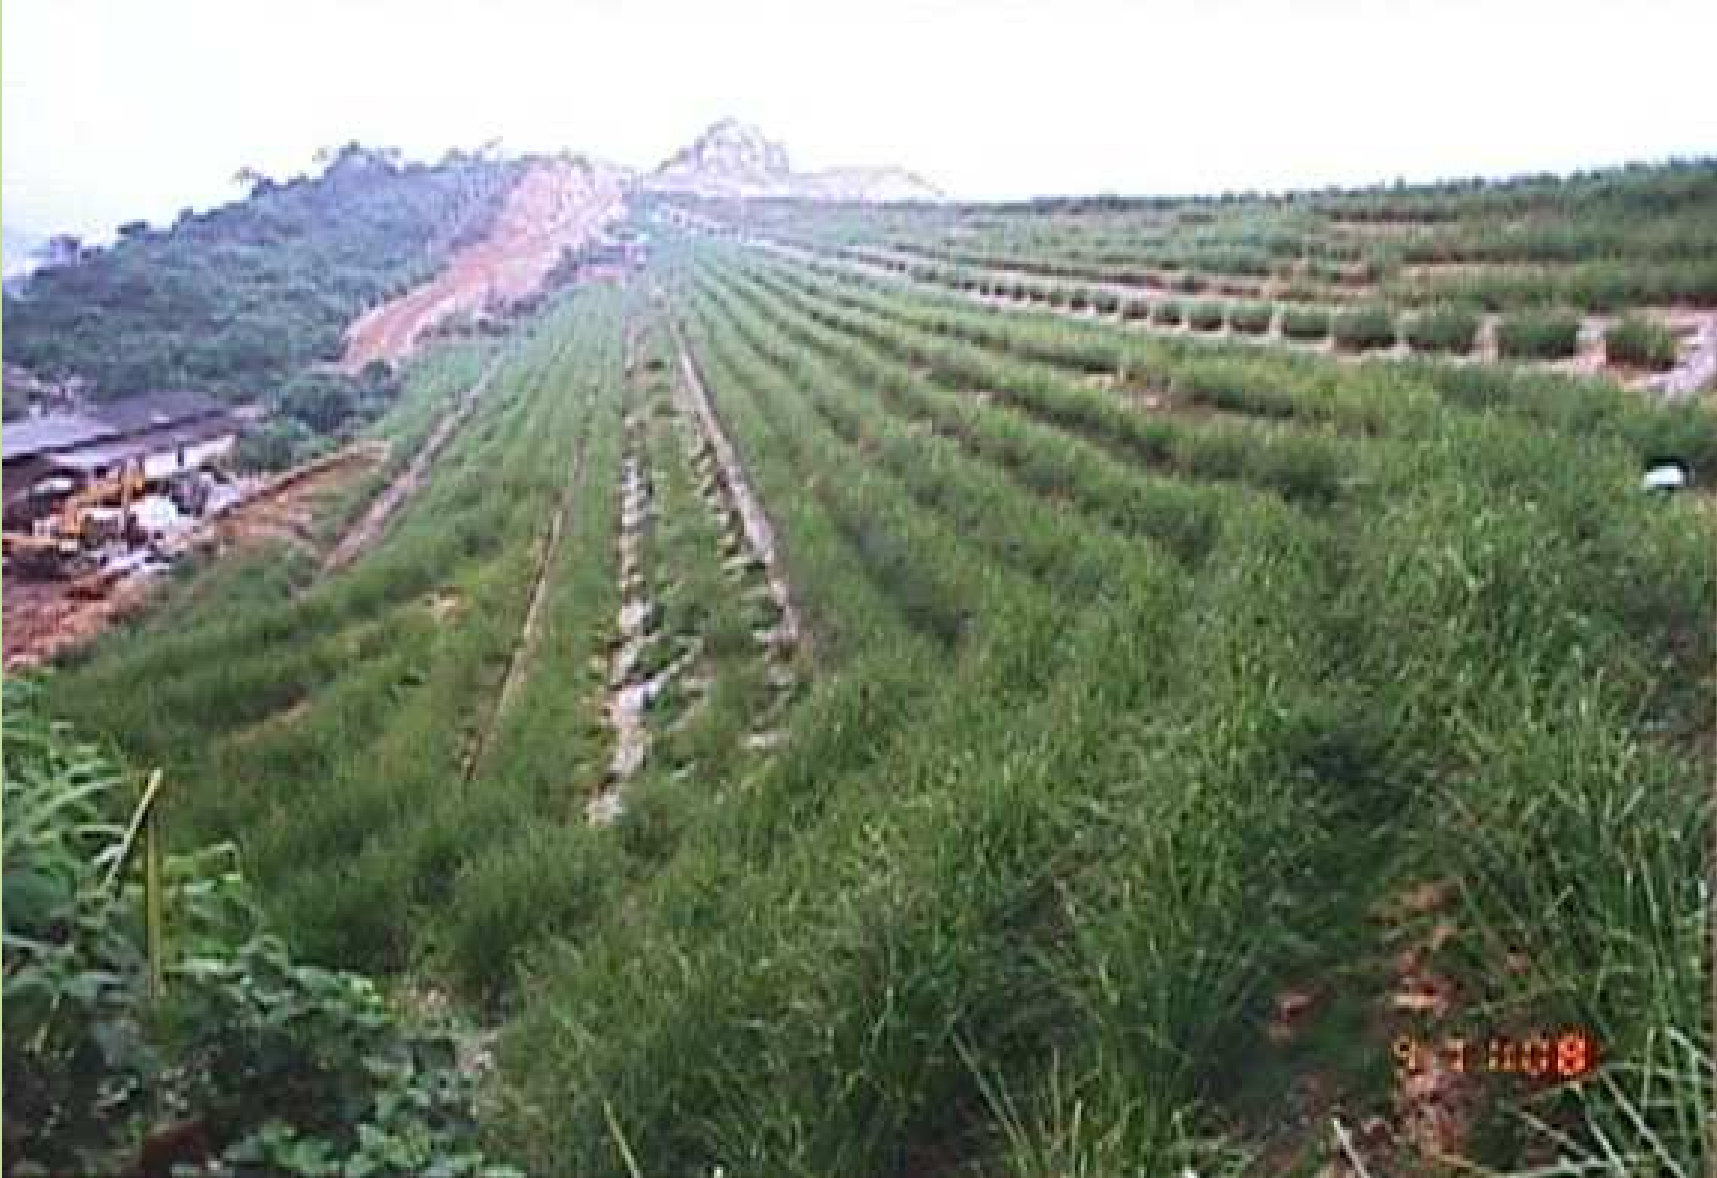
# China Erosion control on a large dam wall in Guangdong Province

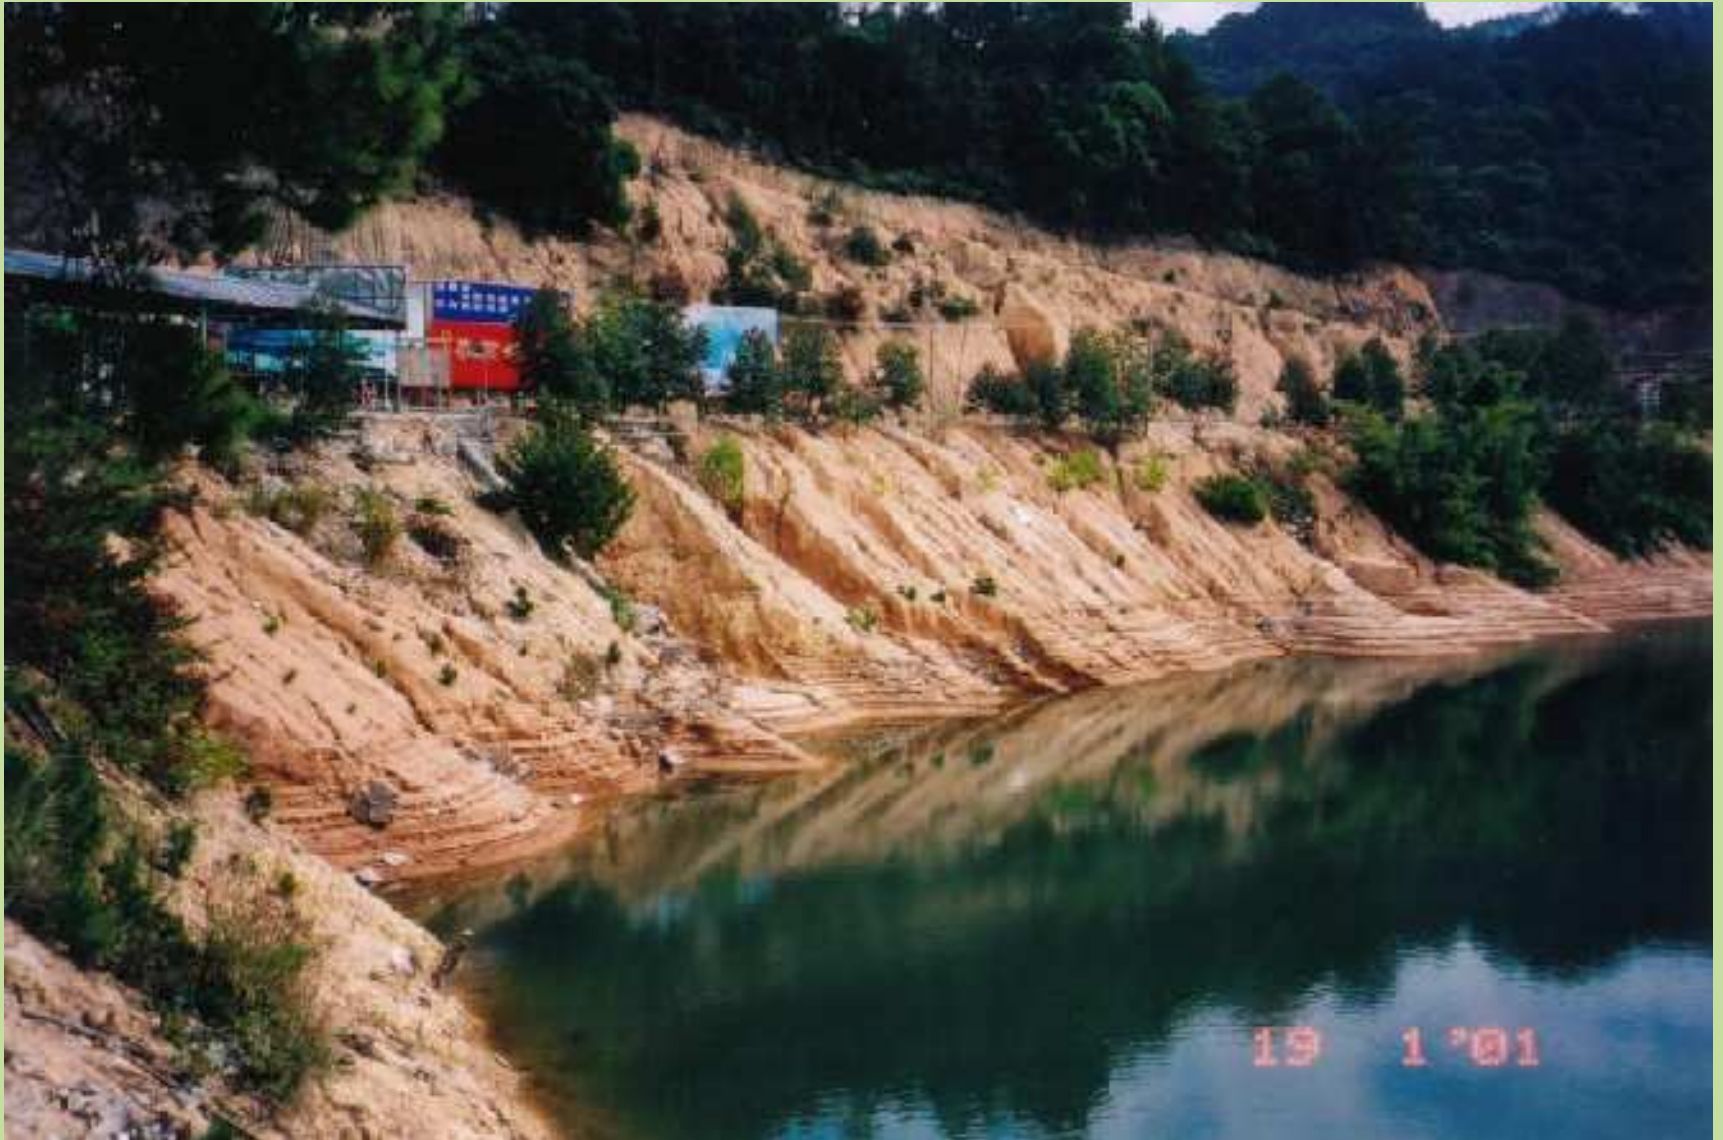
# China - waves badly eroded surface of draw-down area of a large water reservoir in Guangdong Province

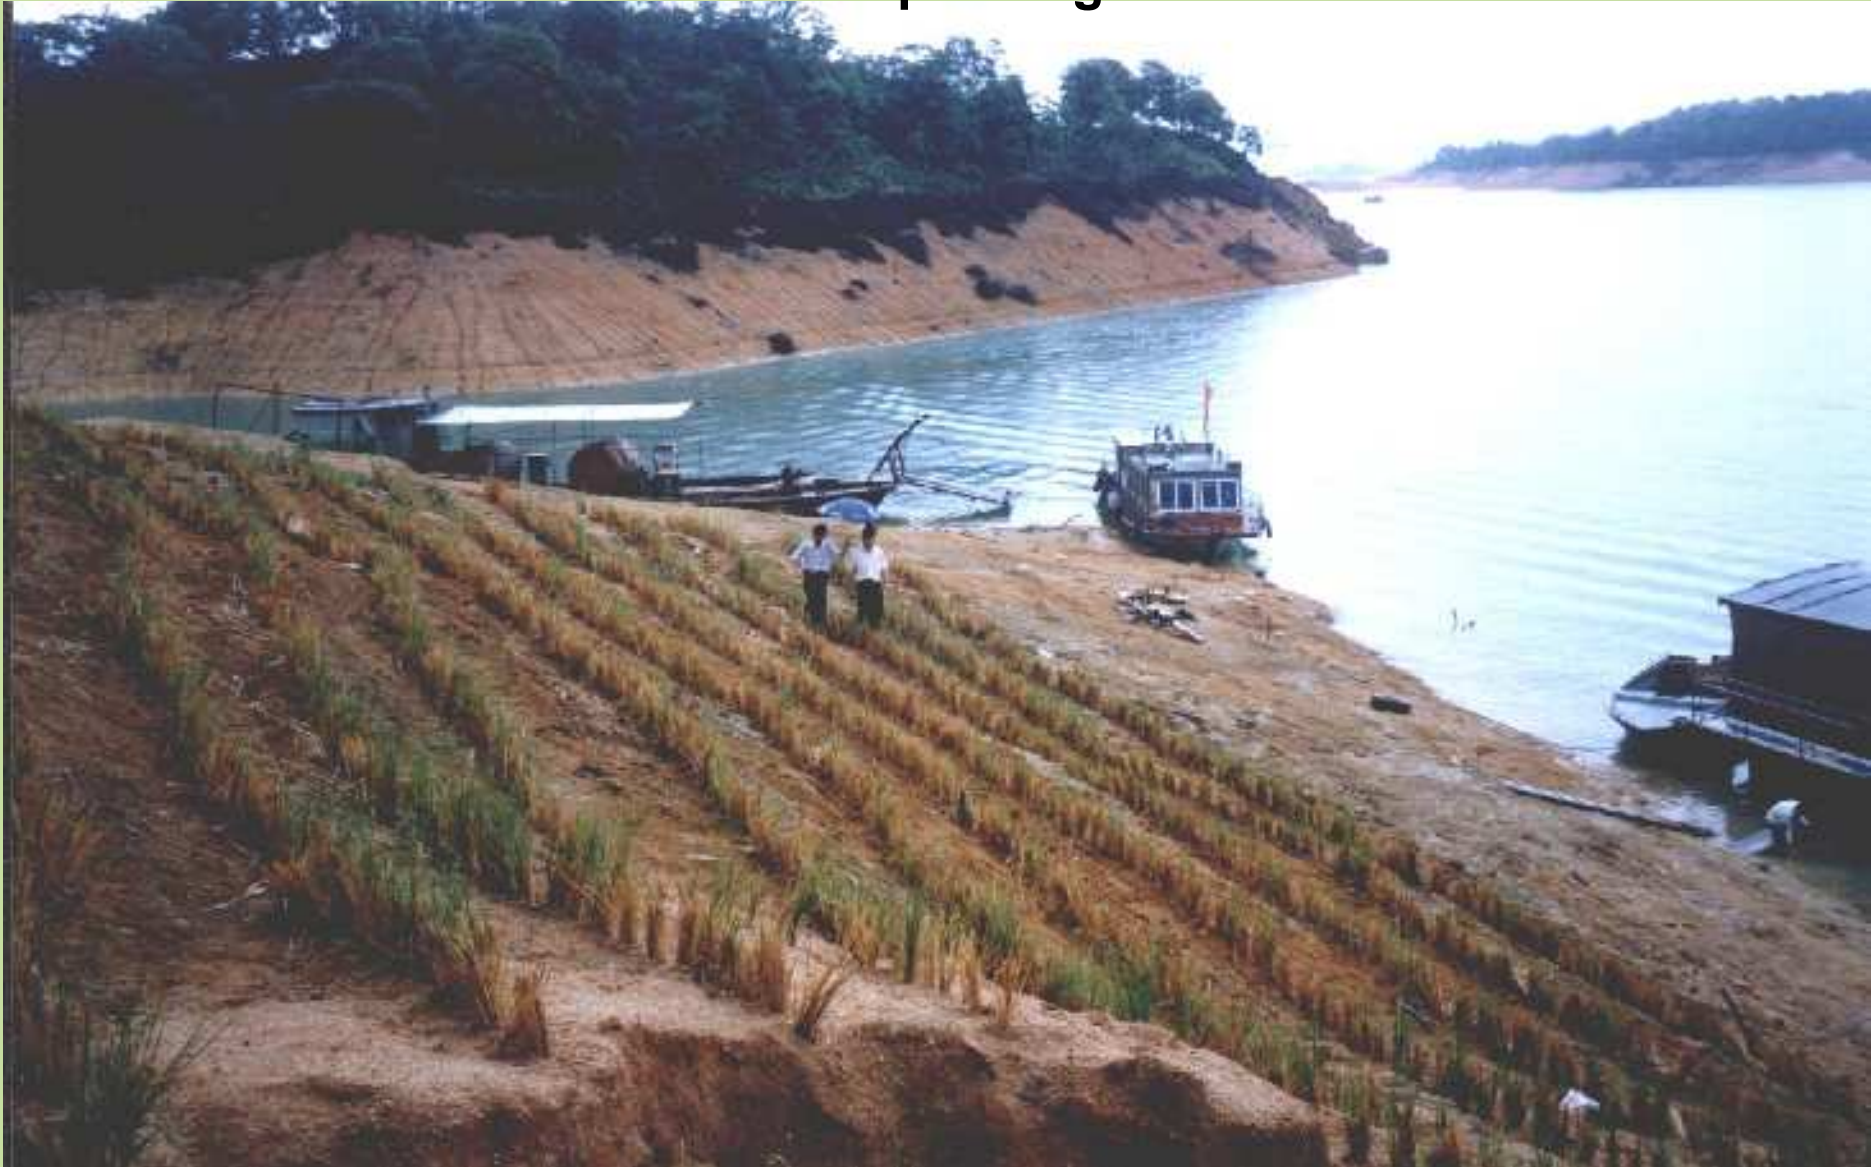
## Draw-down area - Two weeks after planting

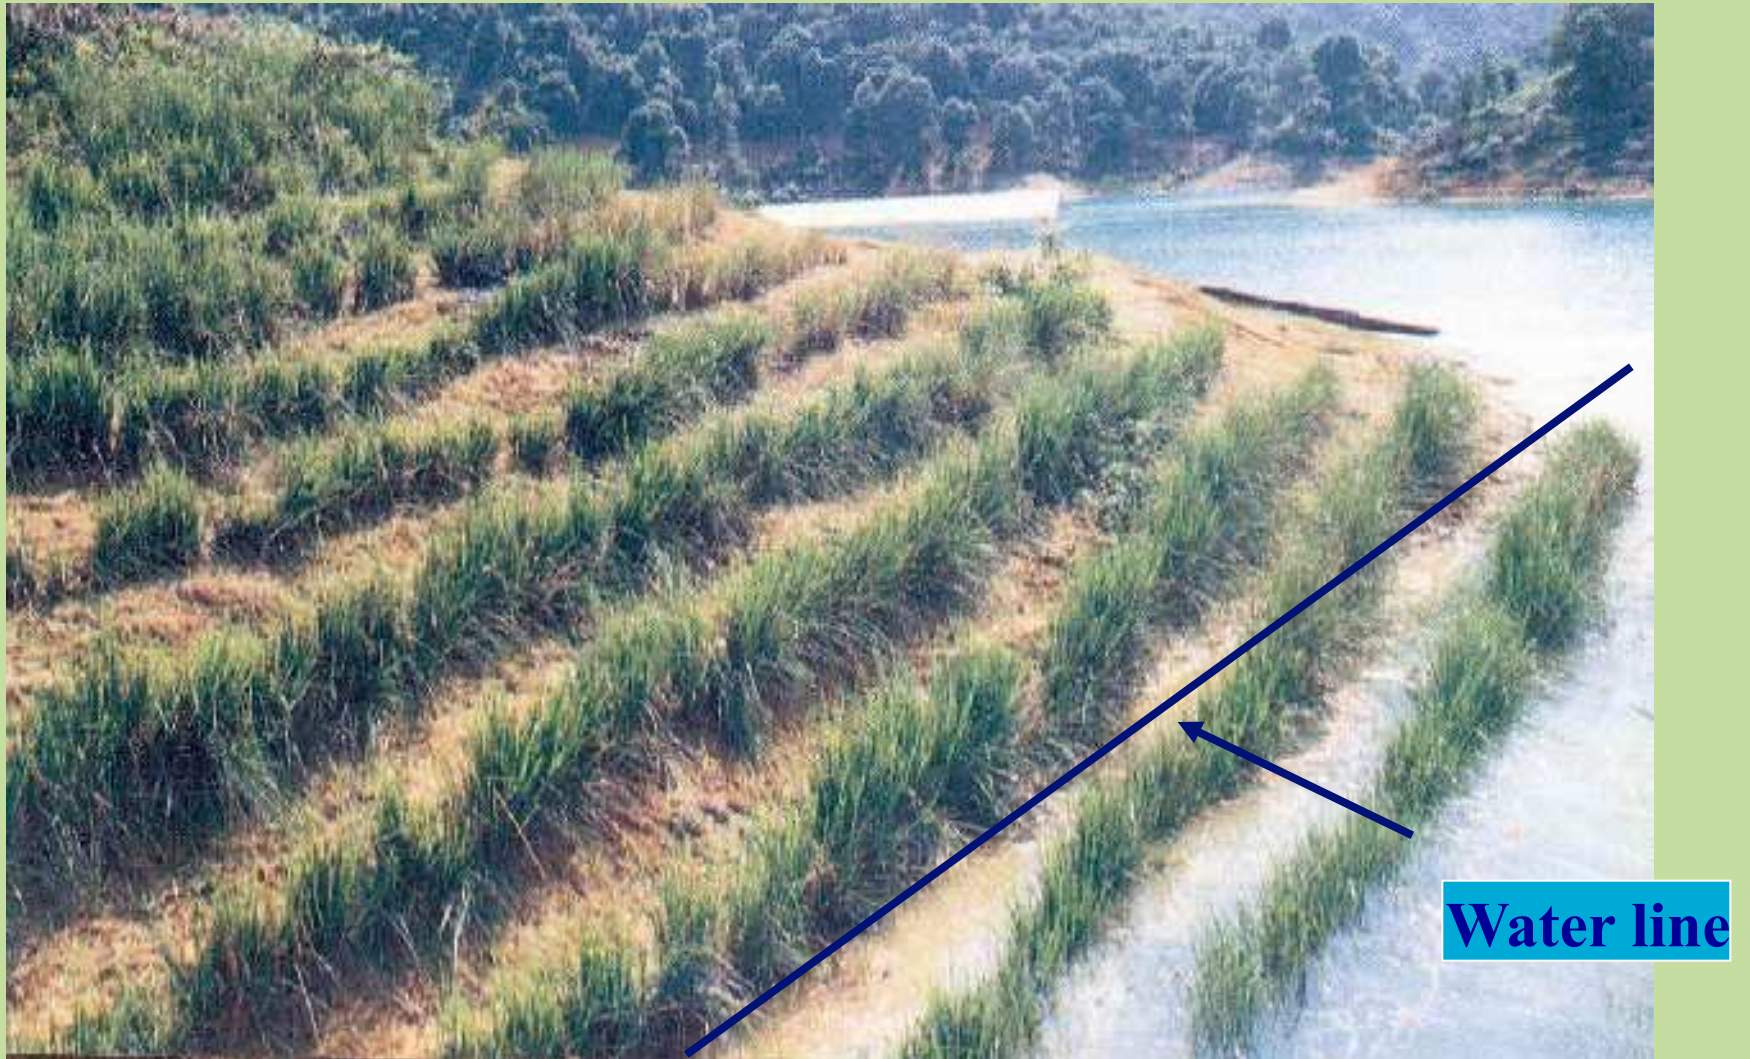
**Draw-down area three years after planting – note vetiver can survive at least three months of total submersion**

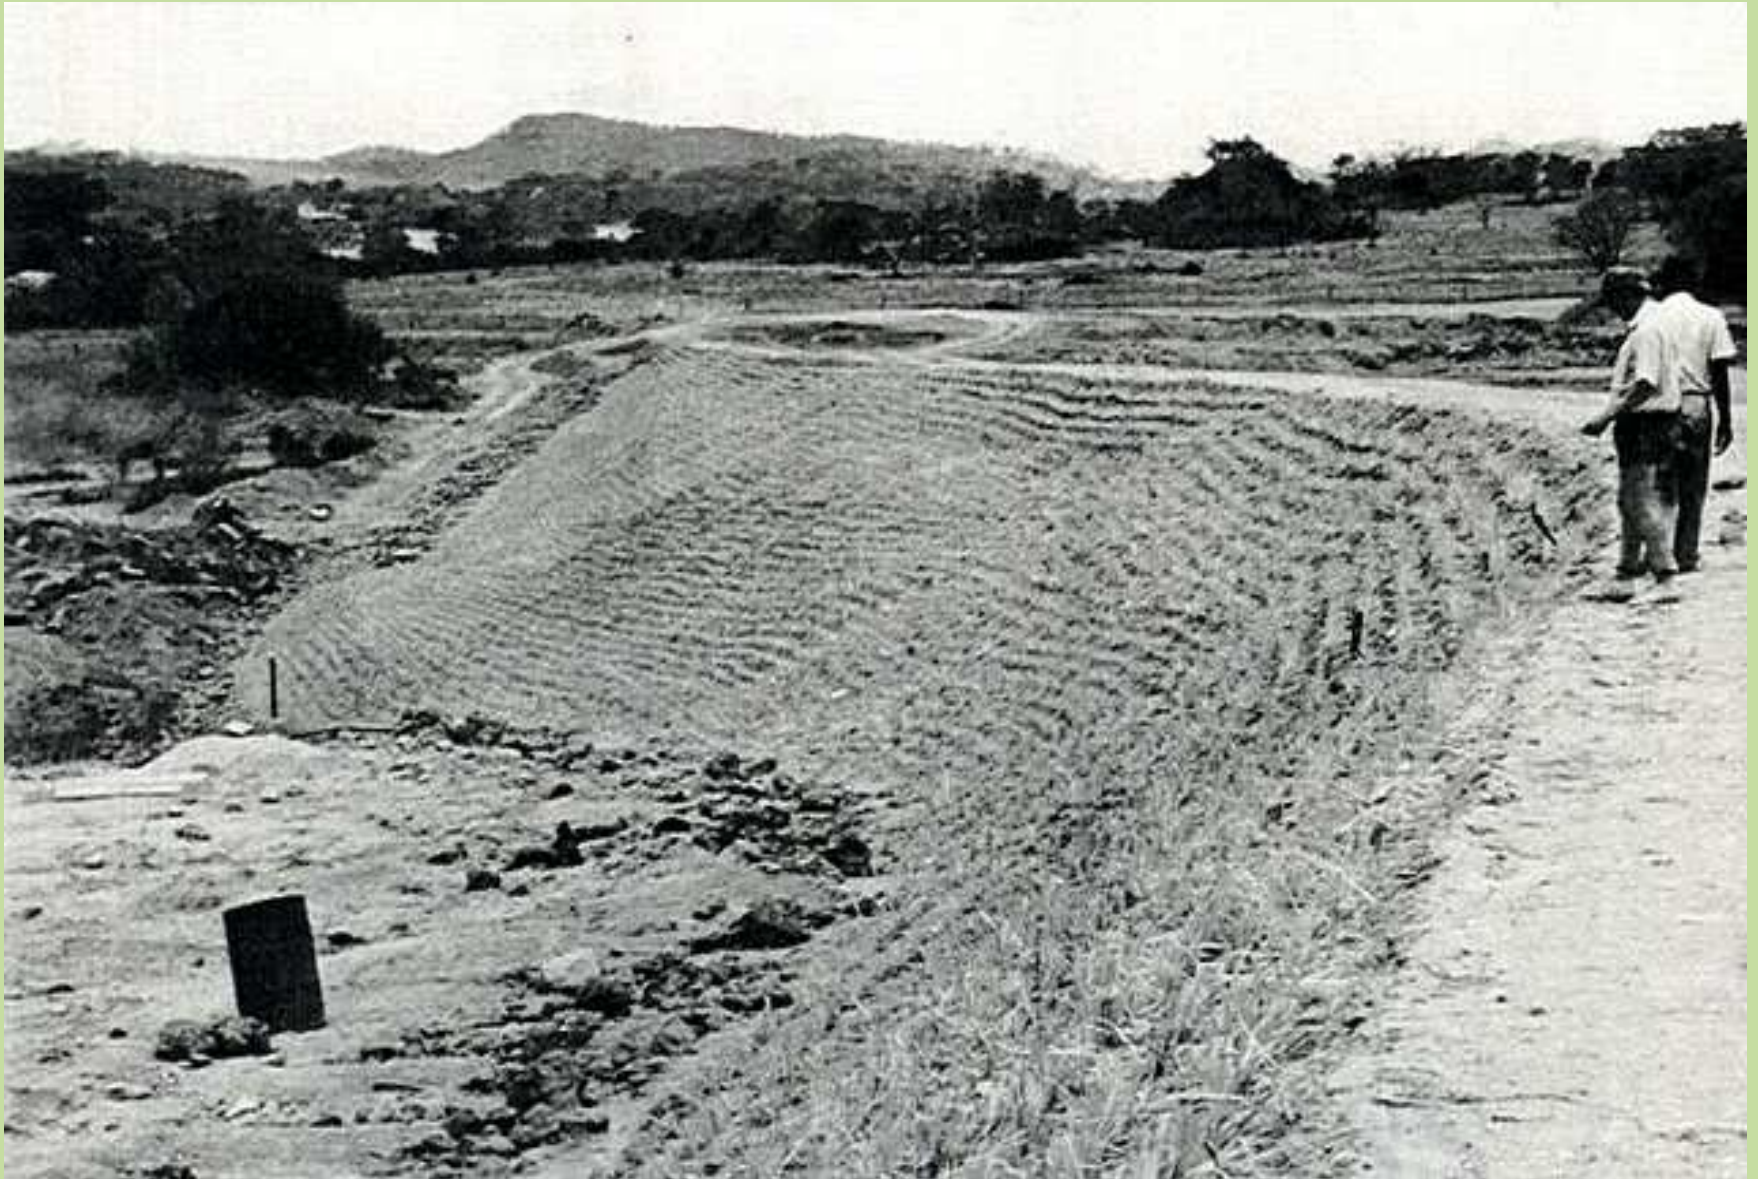
# Zimbabwe - A large farm dam stabilised with vetiver
